Navajo Abandoned Uranium Mine

Site Screen Report

Yazzie No. 2 AUM Site

Navajo AUM Western Region

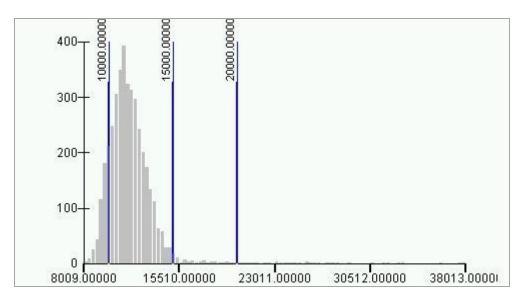
The following chart and statistics were generated by ESRI ArcGIS 9.3.1, and show the general distribution of the site gamma radiation measurements. The horizontal X axis represents the gamma radiation reading levels in cpm (lowest levels to the left). The vertical Y axis represents the frequency of each gamma radiation level.

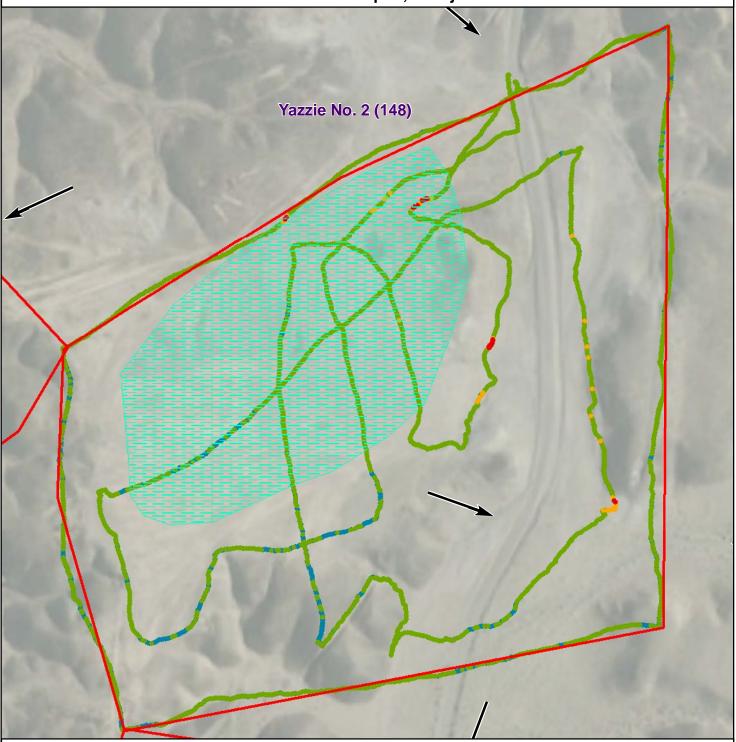
A total of 3,977 gamma radiation measurements were collected from the mine site, ranging from 8,009 cpm to 38,013 cpm. The measurements are represented in Figures 1 and 2.

Figure 1 - Gamma Radiation Measurements, Above Two Times Background **Yazzie No. 2 (148) Coalmine Mesa Chapter, Navajo Nation Yazzie No. 2 (148)** Legend General Slope Direction **Gamma Radiation Measurements** Observed Reclamation Area < 2X Backgound Feet Mine Site Boundary > 2X Background Gamma survey conducted 11/2010 Measured as counts per minute (cpm)

Average background 11,250 cpm
